# In-Field Monitoring of the Durability of Composite Materials

20 August 2001

G. F. HAWKINS, G. L. STECKEL, J. P. NOKES,  
and J. L. BAUER  
Space Materials Laboratory  
Laboratory Operations

CALIFORNIA DEPARTMENT OF TRANSPORTATION  
Sacramento, CA 94273-0001

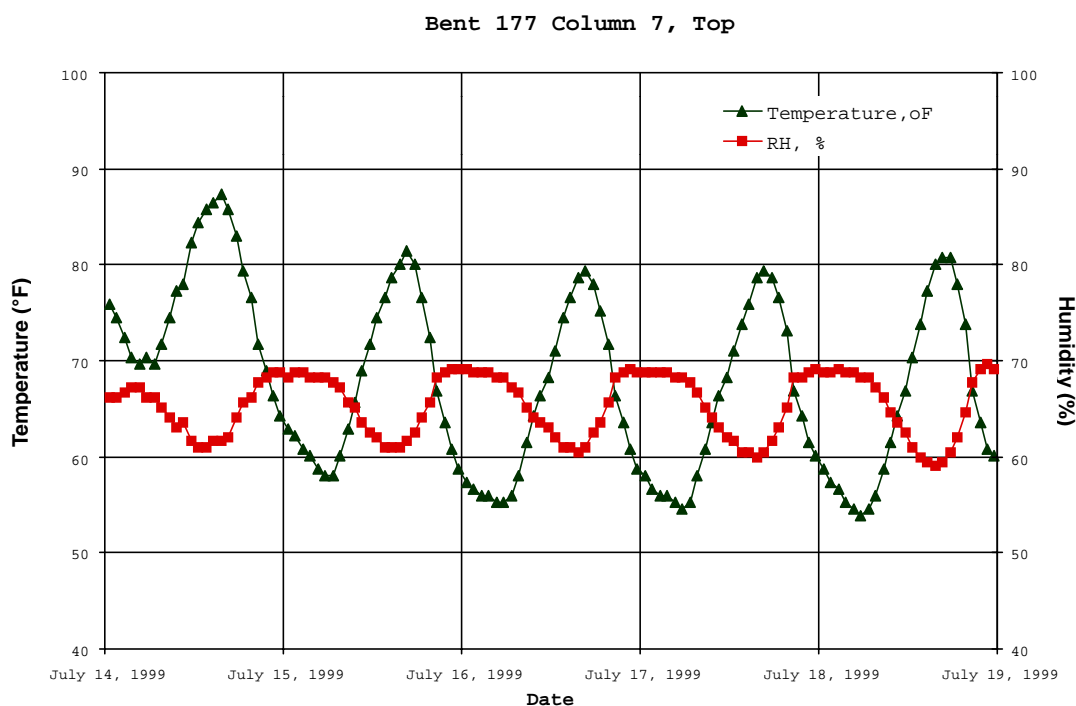
It is apparent from the data that the temperature and the humidity data are out of phase with each other. The humidity data is falling when the temperature data is rising. To make sure this data is consistent, all of the sensors were studied at different time periods and they all showed the same effect. For example, the data in Figure 3.9 shows the same sensor in the winter of the same year when the temperature is much colder. The same effect is evident.

Figure 3.8. Typical temperature and relative humidity data taken during five days in the summer of 1999. The labeled dates indicate midnight at the beginning of that day.

In other words, as the temperature rises, the air is able to hold more moisture. For the relative humidity to remain in equilibrium with the concrete, additional moisture needs to be added. The concrete cannot add the moisture quickly enough to keep the relative humidity in equilibrium; consequently, the relative humidity decreases. The opposite occurs when the temperature decreases causing the relative humidity to rise. In summary, the day-to-day variations stem from the concrete's inability to supply or extract moisture as quickly as the temperature changes.

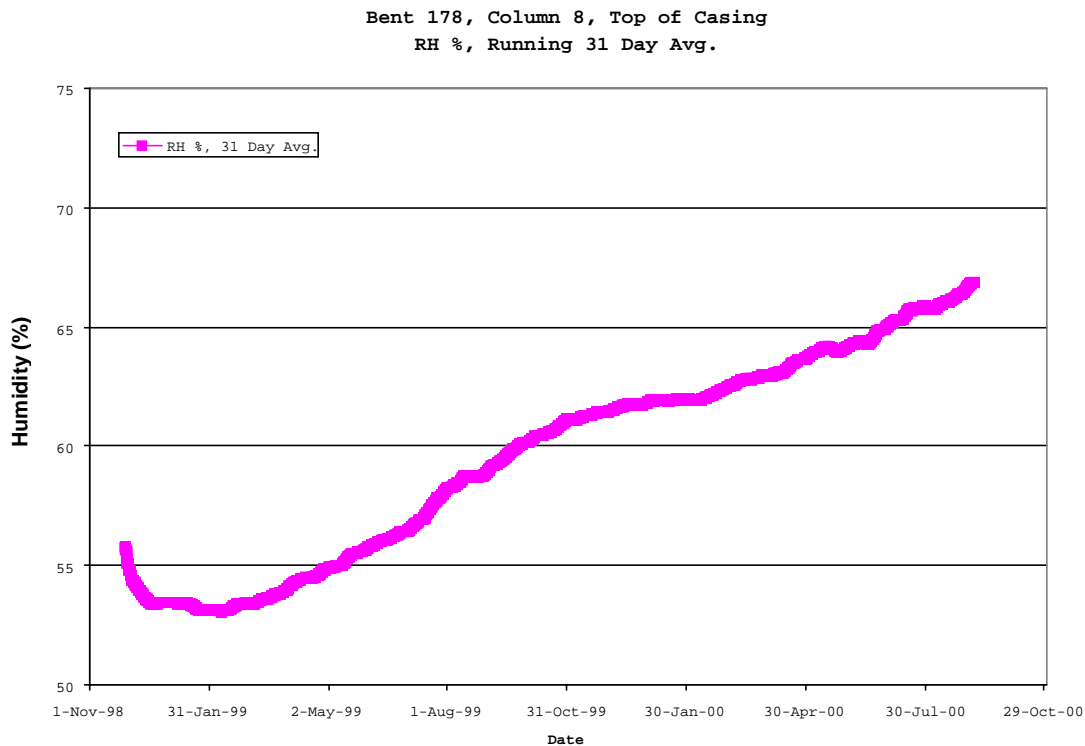
Figure 3.10. A 31-day running average of the relative humidity of column 8 in Bent 178.

The first thing that is evident from this data is that for the first six weeks, the sensor measures a decreasing humidity level. The humidity level reaches a minimum at the end of January when the area is flooded. After this initial dry-out period, the humidity monotonically increases for the remainder of the measurement period.

After the initial dry-out, the data in Figure 3.10 show how the humidity contained in the concrete increases with time over the remaining two-year period. The 31-day average seems to be the proper integration time because it did not smooth out all of the detail, yet it eliminated the day-to-day variations that confused the data interpretation.

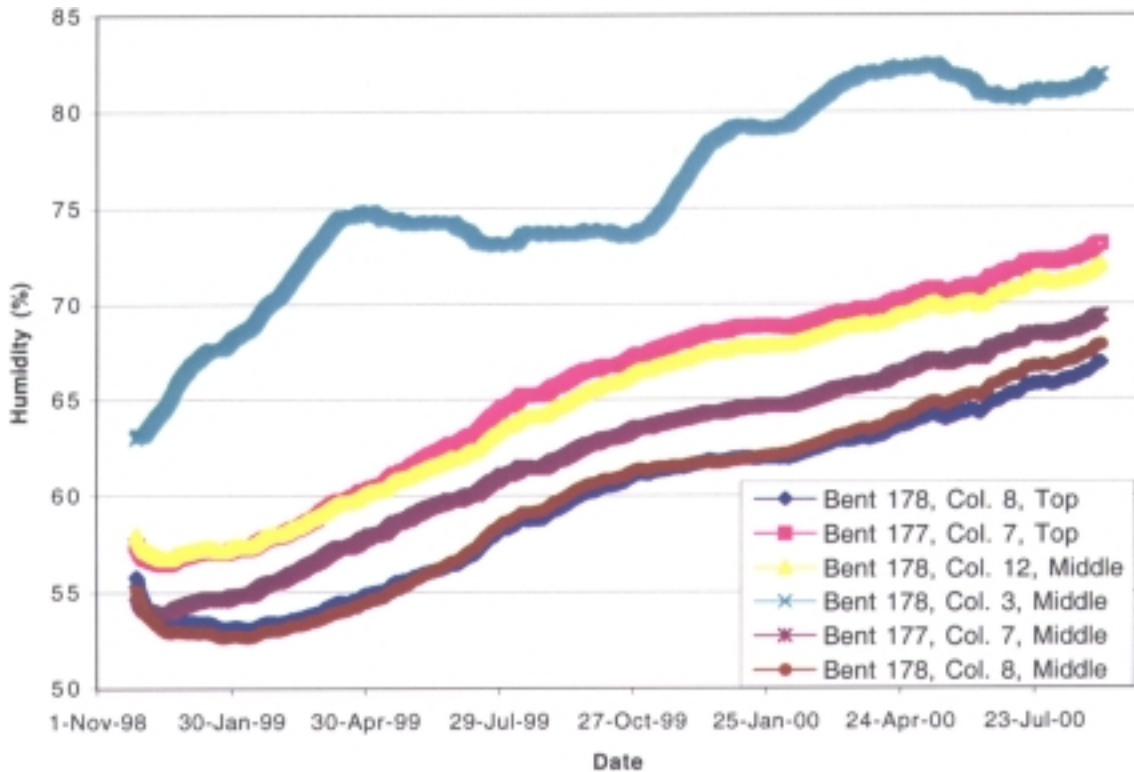
The 31-day running average was calculated for all of the sensors, and the results are shown in Figure 3.11. As can be seen, the data from five of the sensors were essentially the same except for the data from the middle of column 3 on Bent 178. This particular sensor either is malfunctioning, or the seal may be violated, allowing an external source of moisture to affect the readings. Because the data are so different from the other five sensors, we will assume it is anomalous and not discuss it further.

Figure 3.11. A 31-day running average of the relative humidity of all of the columns instrumented.

The water content of the columns increases throughout the first year with an indication of reaching a constant value in January of 2000. At that time, the area was flooded, and the water content increased again. This trend is uniform across the five different sensors and shows no sign of abating. We can only assume that the increase will continue until the columns are saturated with water.

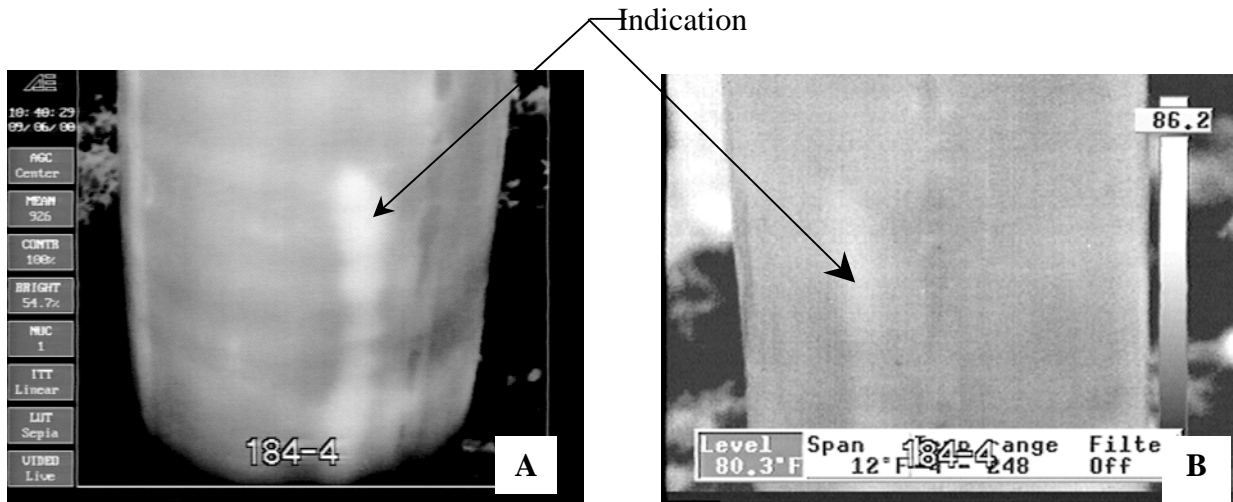
Figure 4.2 Comparison of images of the same indication from (a) Amber Radiance 1 camera and (b) the FLIR 570 Camera.

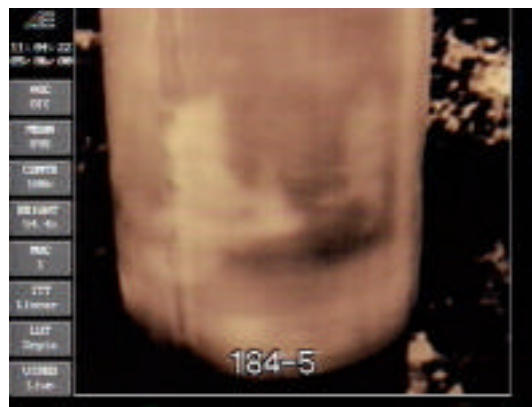
Figure 4.7. Typical IR image of a reinforced column. Note the caption with bent and column number. The information on the left hand side of the image is related to different camera parameters.

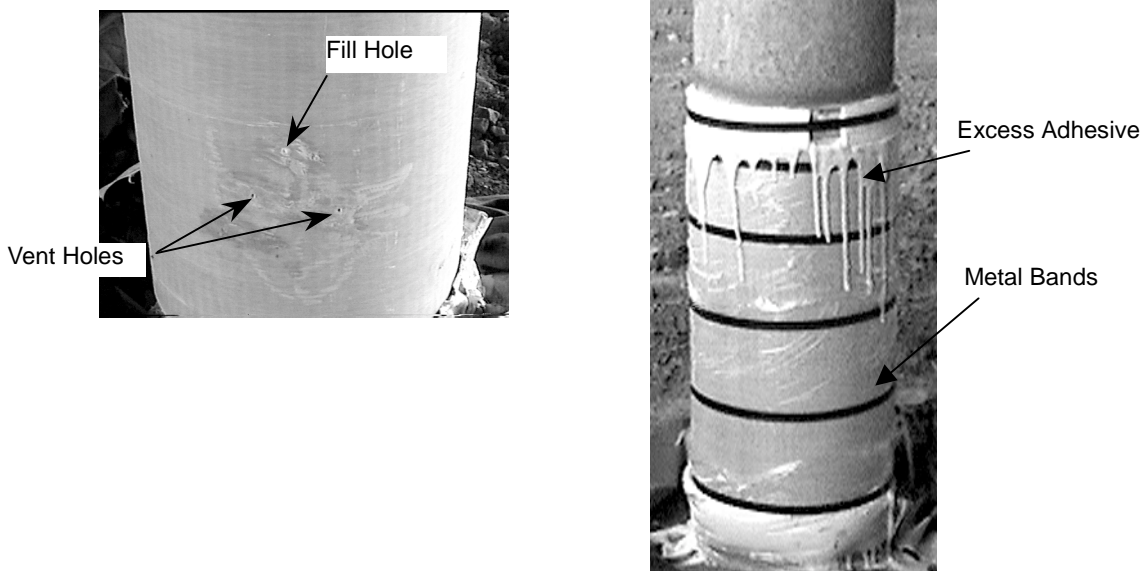
Figure 4.9. Aspects of the retrofit case assembly and repair.

The completed assembly was then put under compression using a sequence of metal bands. After ambient temperature curing of the adhesive, each casing assembly was inspected for voids by a CA State inspector using the sounding technique. Voids located during the initial inspection were repaired using a “drill and fill” procedure whereby fill and vent holes are drilled into the suspect area, and adhesive is injected into the void. Both the banding and the column repair are shown in Figure 4.9.

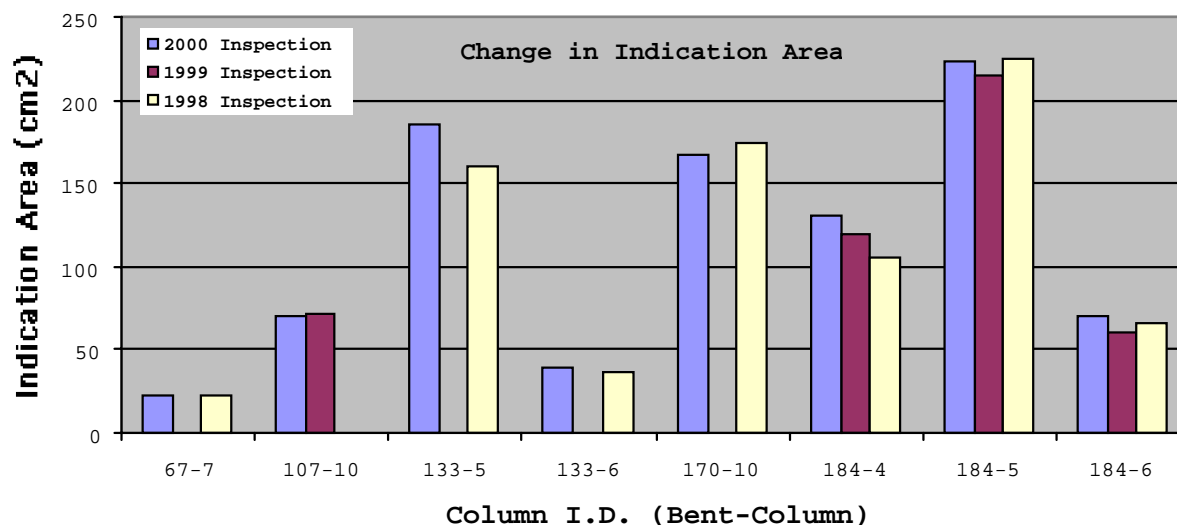
Figure 4.11. Comparison of measured indication areas over the course of the 3-year investigation.

an increase in the area of more than 25% in the measured area would be required to demonstrate growth in a particular indication. Figure 4.11 is a representation of the measured areas of the unbond indications. None of the eight columns showed a significant increase in the indication area. This suggests that the time scale required for environmental water to infiltrate the columns and increase the unbonded area is longer than 3 years.
